Manhole Inspection Summary

Manhole # S17E1_015MH

Location Address: **2814 delmont av**

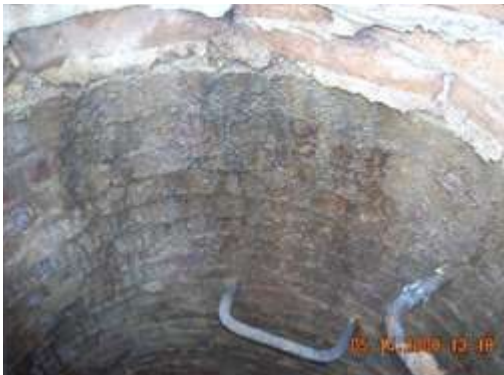
Defect 3

Infiltration: ☐ None ☒ Joint ☐ Cracks ☐ Mortar ☐ Roots ☐ Wall

infiltration @ chimney/frame joint

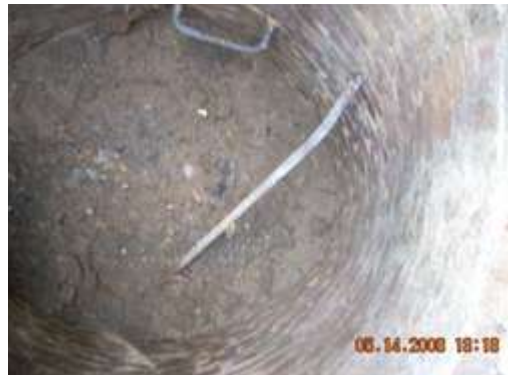
Defect 2

Condition: ☐ Sound ☐ Cracked ☐ Root Intrusion ☐ Deteriorated ☐ Leaks ☒ Debris

channel debris

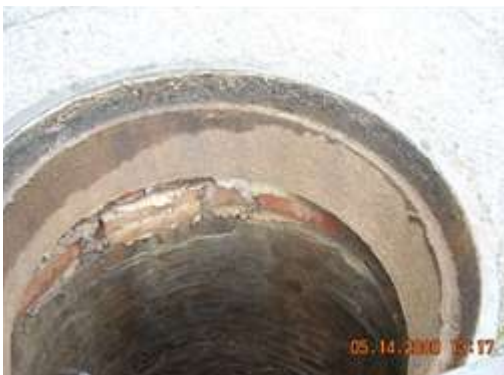
Defect 1

Condition: ☒ Sound ☐ Cracked ☐ Root Intrusion ☒ Loose Brick ☒ Deteriorated

loose bricks, deteriorated, inflow evidence from sheeting

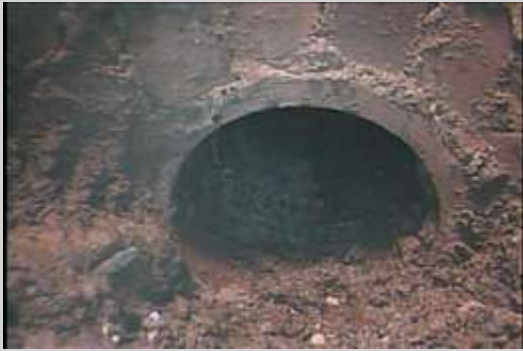
12 O'Clock Outflow

8 in. Circular Gravity Sewer
Pipe Out @ 12 O'Clock

Deposits: ☐ None ☒ **Mud** ☐ Sludge ☐ Debris ☐ Grease

Silt Depth: **2** (in.) Deposits Extent: **Light**
